A TWO-STAGE APPROACH TO DAMP INVESTIGATION IN A THREE BEDROOM RESIDENTIAL BUILDING IN KUMASI, GHANA

K. Agyekum^{1*} and J. Ayarkwa¹

¹*Department of Building Technology, Kwame Nkrumah University of Science and Technology, Kumasi, Ghana*

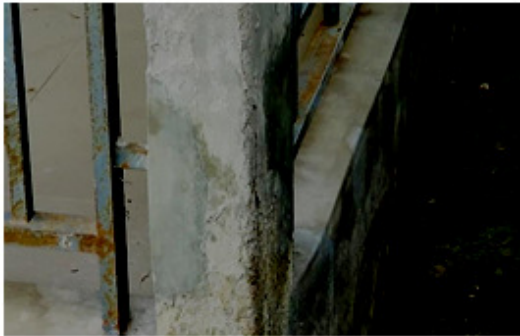
Figure 5a. Crack in column

The site inspection revealed a lot of interesting issues on the building. Blistering of paint, flaking of plaster and render, surface efflorescence, green algae (eastern orientation) and cracks in the column located at the balcony area were among the symptoms identified. Along all the external and internal walls, dampness extended to heights of about 900 mm. On the compound where the building is located, it was realized that a portion of the soil found in the area had changed colour to brownish yellow and this indicated the presence of ions in the soil (Burkinshaw, 2010). This colour was identified on the surfaces of the walls located in the western and eastern orientations. These symptoms identified in the walls point to the possibility of rising dampness. Rising dampness results from the capillary suction of moisture from the ground into porous masonry building materials (Halim and Halim, 2010; Ahmed and Rahman, 2010). Among the visible symptoms of rising damp is dampness on the lower parts of walls, sometimes up to 1.5 m in horizontal bands (Rirsch, 2010). Rising damp may also present itself as salty brownish yellow patches of plaster or décor just above the height of skirting boards (Burkinshaw, 2010). Other sources also list blistering of paint, surface efflorescence, flaking of mortar, etc. to be part of the symptoms associated with rising dampness (Halim and Halim, 2010).

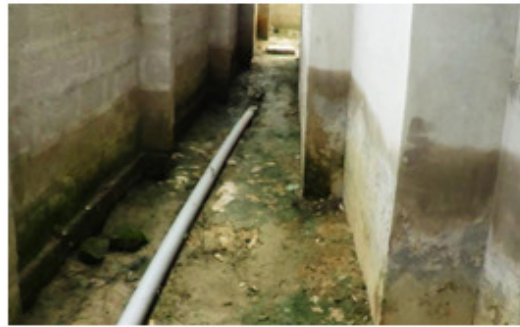
Figure 5b. Green stain on external wall

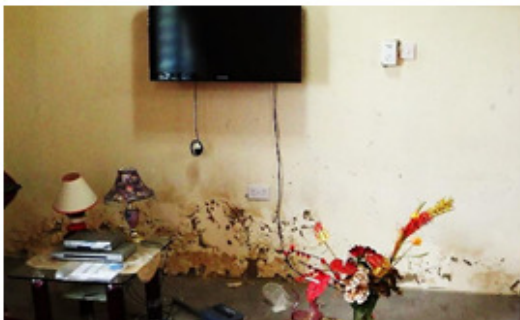
Figure 5c. Internal blistering of paint

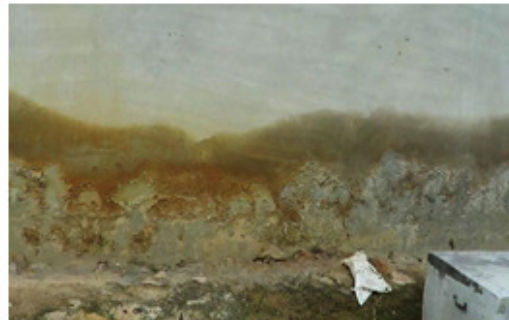
Figure 5d. Brownish-yellow stain on external wall

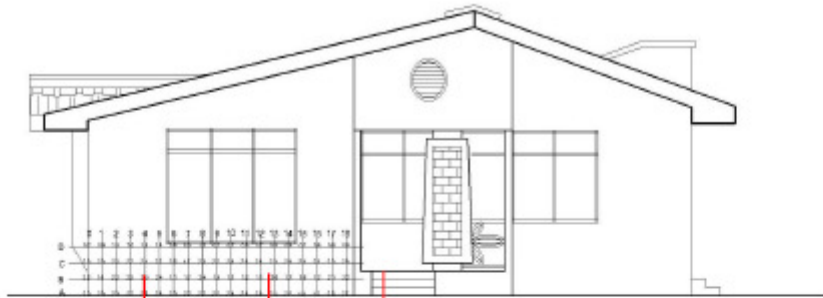
Results from the moisture content measurements on the external walls located in the western orientation (Figure 6a) showed that dampness was dominant in the zones highlighted in red (in rectangles). This is because for most of these grid points the moisture contents measured were greater than 2.0, indicating high levels of dampness in those zones.

Figure 6a. Moisture contents on walls in the western orientation

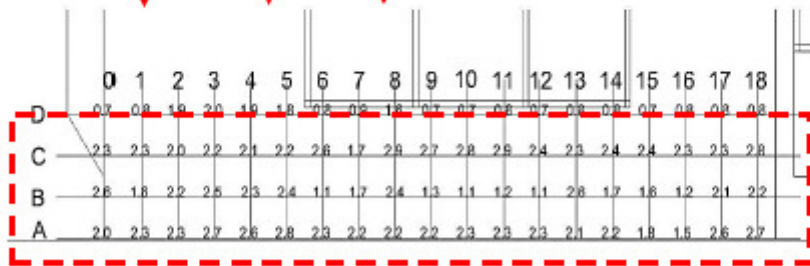
Figure 6b. Enlarged 300mmx300mm grids showing moisture contents on walls in western orientation

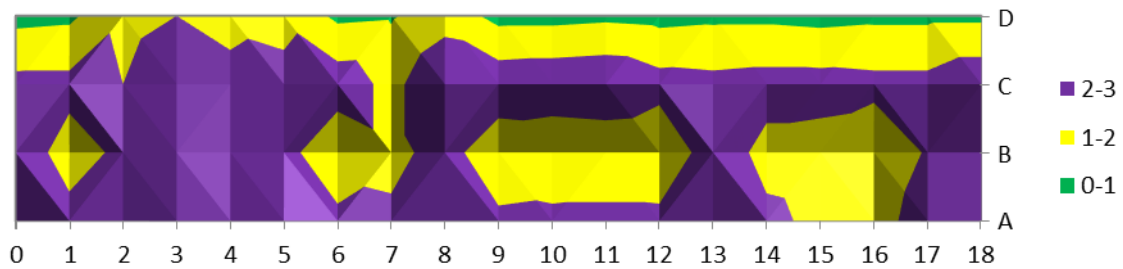
Figure 6c. Contour map showing the distribution of moisture contents along and across the external wall of the western orientation.

Figure 6c is a coloured contour map which shows areas in the walls of the western orientation severely affected by dampness. From Figure 6c it can be seen that all across and along the walls of the western orientation dampness was present and severe (yellow and purple colours). However, the dampness was very dominant in the zones that can be seen in purple because for most of those zones the moisture contents measured were greater than 2.0, indicating high levels of dampness. Furthermore, grid points A2-A5 through to C2-C5 were severely affected (As the purple colour stretched all along and across those grid points).

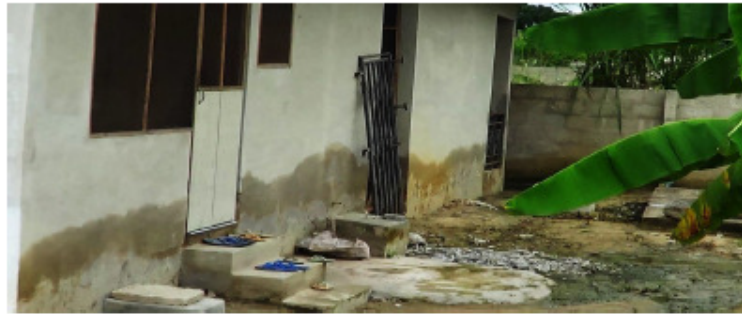
Figure 7a. Walls in the southern orientation showing signs of dampness

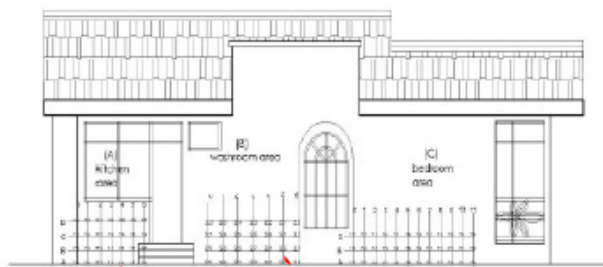
Figure 7b. Readings taken on the walls in the southern orientation

Among all the affected walls, moisture content measurements on the external walls of the building in the southern orientation were unusually higher. Figures 7b and 7c show the moisture contents recorded on the walls of the kitchen and the bathroom. The damp zones are marked with the rectangles shown. These are the two wettest areas in the house and normally have lots of plumbing works. Although the very high moisture contents recorded could be due to plumbing leakage in the walls, further detailed work conducted in these two areas did not show any such leakage.

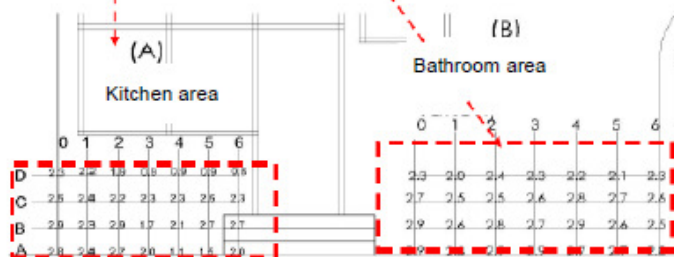
Figure 7c. Moisture content distribution on walls of kitchen and bathroom in the southern orientation

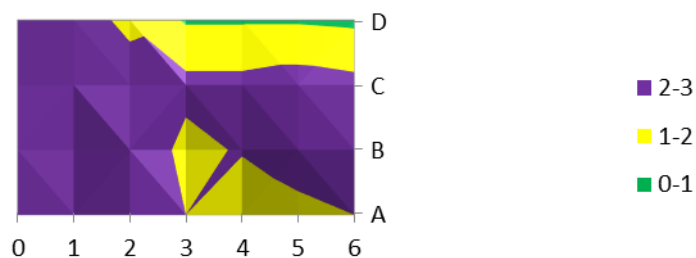
Figure 7ci. Contour map showing the distribution of moisture contents along and across the kitchen wall located in the southern orientation

The contour map in Figure 7ci shows the areas with severe dampness (indicated in yellow and purple). The contour map shows the damp zones where the moisture contents recorded are greater. Those zones (areas shaded in purple) were greatly identified between grid points A0-A3, B0-B3 and C0-C3.

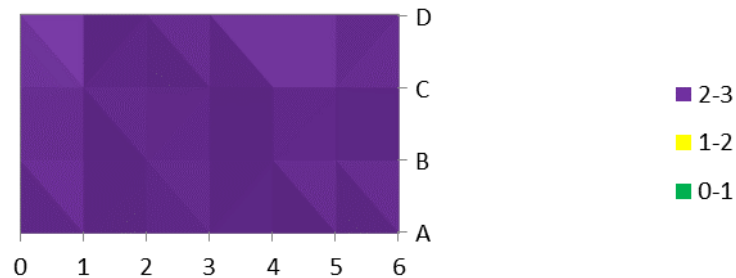
Figure 7cii. Contour map showing the distribution of moisture contents along and across the bathroom wall located in the southern orientation

For the walls of the bathroom located in the southern orientation dampness was so dominant that readings from the moisture meter taken on the entire wall were greater than 2%. The contour map (Figure 7cii) gives a clear picture of the problem in the walls of the bathroom. The purple colour shows the areas in the entire bathroom walls which showed significant level of dampness (damp zones).

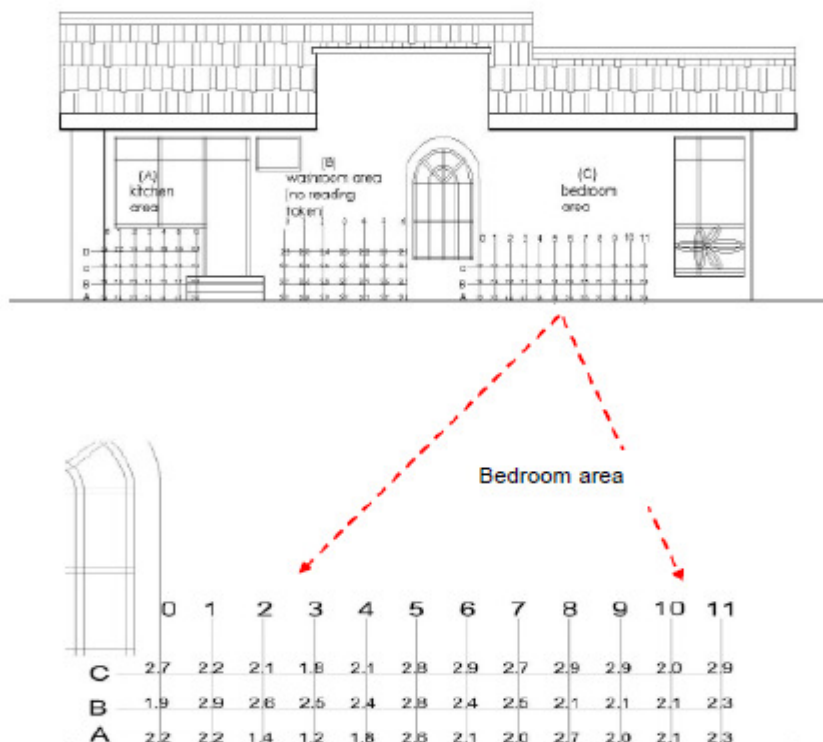
Figure 7d. Moisture content distribution on bedroom walls in the southern orientation

Because the southern orientation of the building was closer to the water body, there could be the possibility of water rising in the walls because of the high water table. This point is buttressed by Figure 7d where the moisture contents recorded on the walls of the bedroom also seemed unusually high, compared to those from the kitchen and bathrooms.

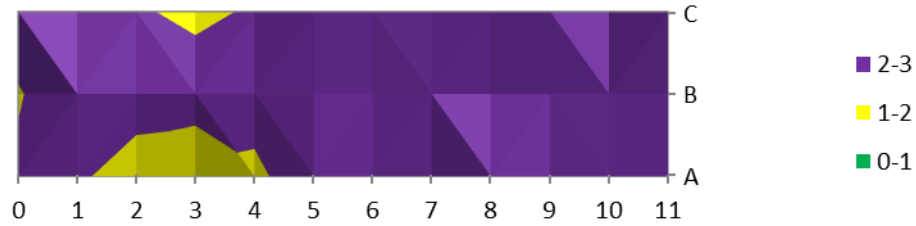
Figure 7di. Contour map showing the distribution of moisture contents along and across the bedroom wall located in the southern orientation

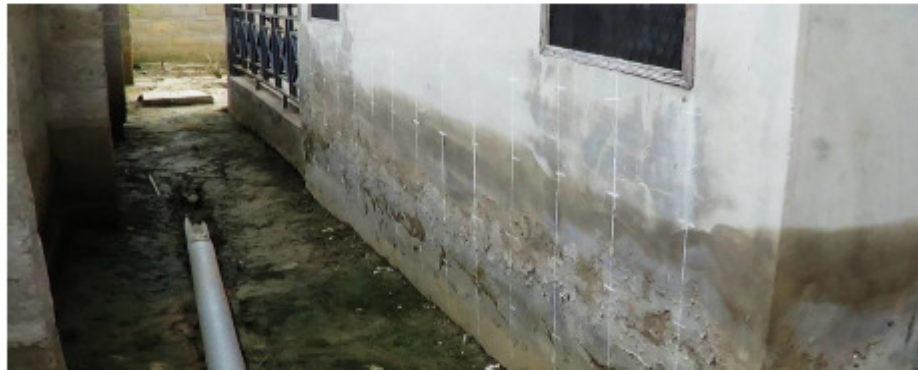
Figure 8a. Eastern orientation showing signs of dampness

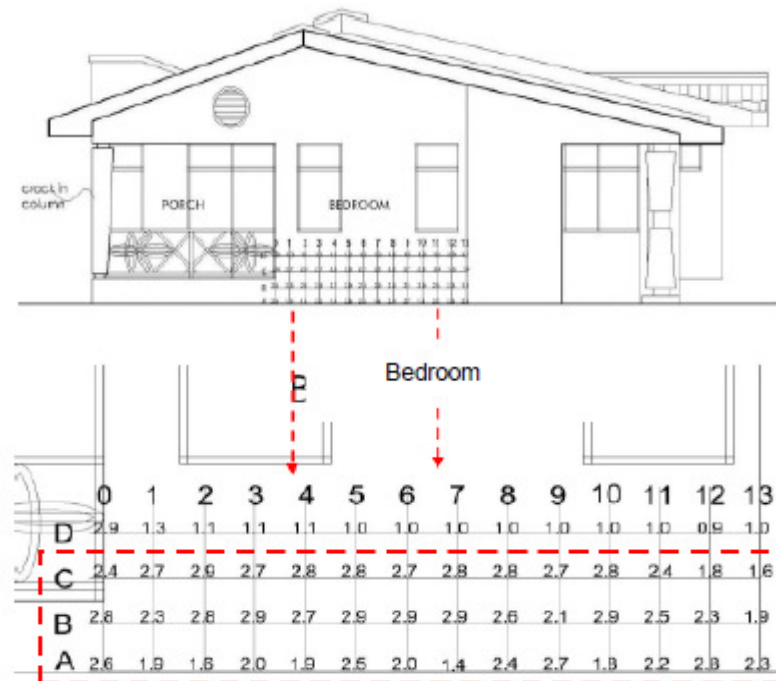
Figure 8b. 300mm x 300mm grids showing moisture contents on the eastern orientation

Results from the moisture content measurements on the external walls of the eastern orientation (back elevation) indicated higher moisture contents on the walls of the bedroom. Figure 8b shows readings taken from the moisture meter on each grid. Grid lines A0-A11, B0-B11, C0-C11 and D0 were identified as the severely affected zones. Though there existed some low level of dampness on some of the grids (A8), dampness recorded in majority of the zones were between 1.5 and 2, an indication of the severity of the problem.

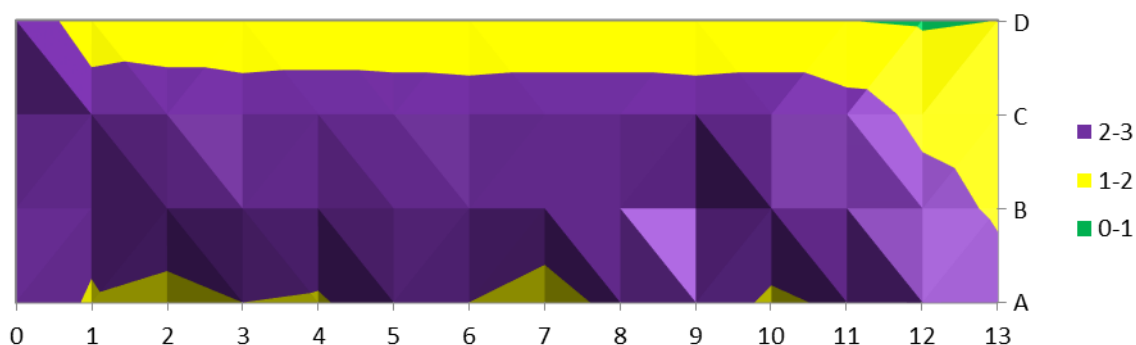
Figure 8c. Contour map showing the distribution of moisture contents along and across the bedroom wall located in the eastern orientation

Moisture contents recorded on the walls of the building showed that the walls oriented in the southern, eastern and western directions showed various levels of dampness. However, the dampness was very severe among the walls oriented in the eastern direction, and were identified as areas where further investigations should be conducted.
