Analysis of Building Defect for Wooden Houses at Flooded area in Kota Bharu, Kelantan

TYPES OF DEFECTS IN WOODEN HOUSES AT FLOODED AREA, KELANTAN

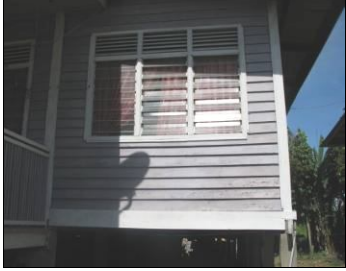
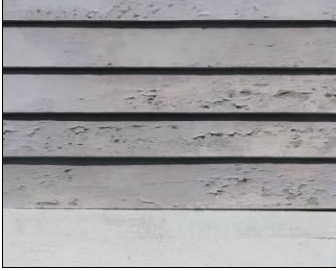
Peeling and flaking of paintwork occurs at external wall caused by the building exposed to the environment. Besides, there is no awning provided and will cause directly contact with rainwater penetration. The location of defect of peeling and flaking of paintwork occurs at in front of the building and at the rear of the building. Refer Photo 1. Insect attack occurs at wood joist at the cellar floor. It occurs caused by the inadequate ventilation. The wood joist is not preserva may cause the insect attacked. The moisture meter reading is about 15% to 25% humidity of wood joisting that insect attack the structure. Refer photo 2.

Peeling and flaking paintwork at in front of building.
2

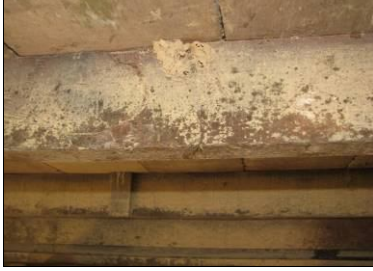
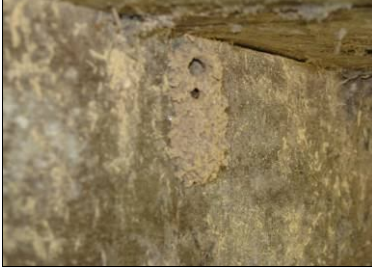
Insect attacks the wood joist.
3

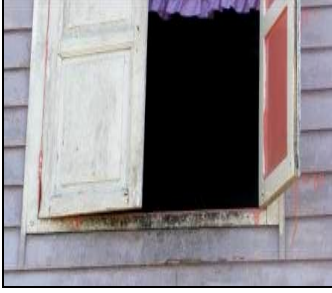
Mould growth occurs at the wall near the window. The black spots or patches are seen at external wall caused by mould growth. The affected areas are likely to be damp. There is no awning provided and it is exposed to the direct sunlight. Refer photo 3. Timber decay occurs at the balcony and at the wall in toilet. The possible cause of timber decay at balcony is caused by the exposed to the rain water. Timber decay also occur at the wall in toilet due to direct exposure to rainwater. Refer photo 4. Defective on window glazed is caused by lack of maintenance approach by the building owner. There are about six numbers of glazed windows are loss and one glass of window is broken. Refer photo 5.

Mould growth at external wall.
4

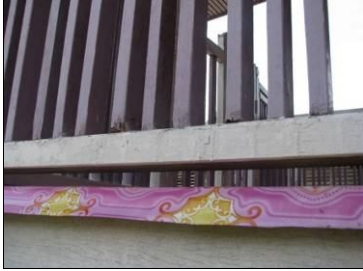
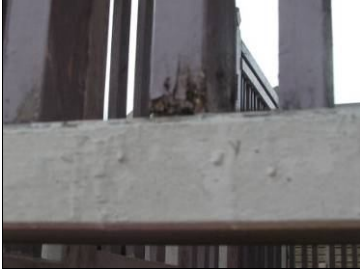
Timber decay at balcony (fence).
5

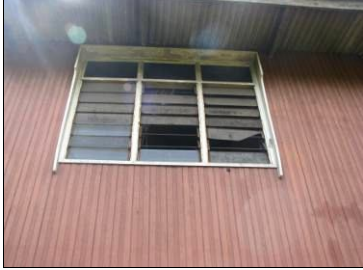
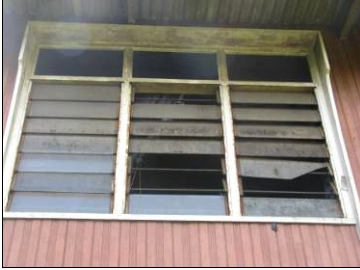
Defective on window glazed
