A TWO-STAGE APPROACH TO DAMP INVESTIGATION IN A THREE BEDROOM RESIDENTIAL BUILDING IN KUMASI, GHANA

K. Agyekum^{1*} and J. Ayarkwa¹

¹*Department of Building Technology, Kwame Nkrumah University of Science and Technology, Kumasi, Ghana*

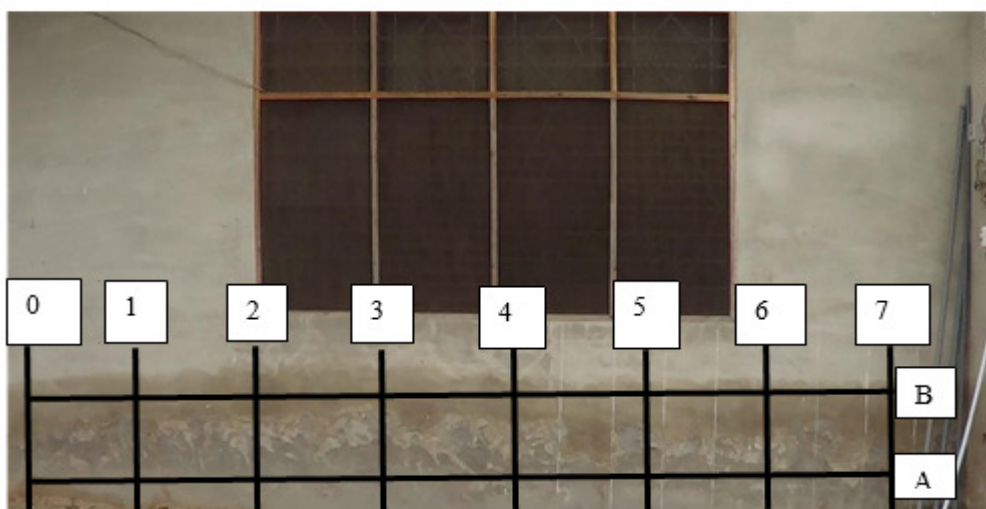
Figure 2: Grid points marked on the wall

Checklists were prepared on which readings were recorded. Grids of 300 mm×300 mm were drawn on all the affected walls. Damp walls in the Southern, Western and Eastern orientations extended up to about 900 mm and grids were drawn as shown in Figure 2.

The gridlines were coded using alphabets (for horizontal gridlines) and figures (for vertical grid lines) as shown in Figure 2.
